**13<sup>th</sup> World Conference on Earthquake Engineering**  
**Vancouver, B.C., Canada**  
**August 1-6, 2004**  
**Paper No. 2578**

## **CYCLIC BEHAVIOR OF TRADITIONAL AND INNOVATIVE COMPOSITE SHEAR WALLS**

**Qiuhong ZHAO<sup>1</sup> and Abolhassan ASTANEH-ASL<sup>2</sup>**

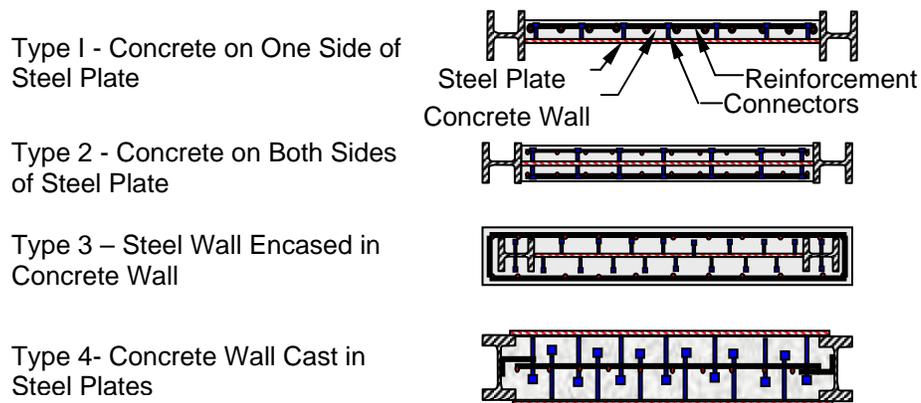
**Figure 1. Composite Shear Wall Systems (Astaneh [6])**

Four common types of composite shear wall systems are shown in Figure 1. The focus of this study was the behavior of type I system, which consists of a steel boundary frame and a steel plate shear wall with a reinforced concrete wall attached to one side using mechanical connectors such as shear studs or bolts. In the AISC Seismic Provisions this type of system is denoted as “Composite Steel Plate Shear Walls, (C-SPW)” (AISC [5]). Main components of this type of system are also shown in Figure 2.

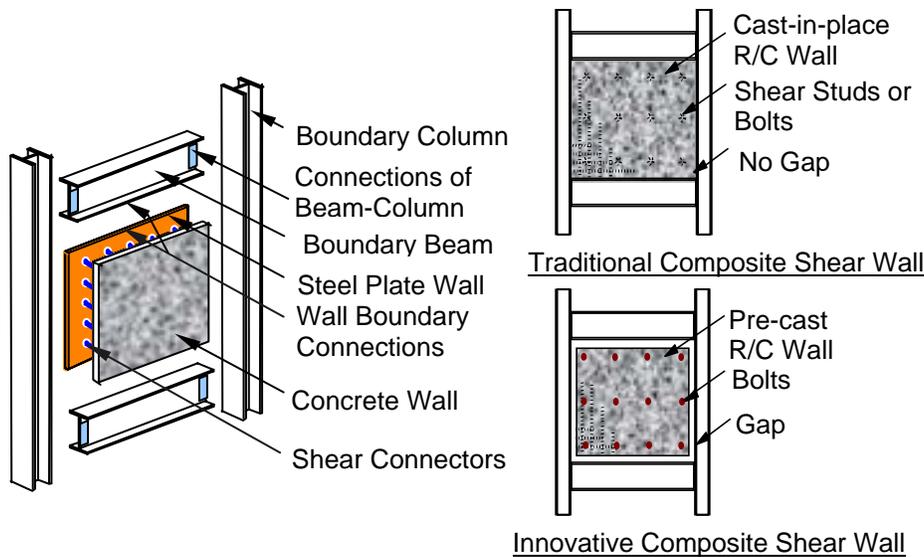
**Figure 2. Main Components of Type I Composite Shear Wall (Zhao [7])**

The study was focused on two configurations of type I composite shear wall system denoted as “traditional” and “innovative”. The innovative system was proposed and designed by the second author (Astaneh [6]). The difference between the two configurations is that in the traditional system the reinforced concrete wall is in direct contact with the steel boundary frame but in the innovative system there is a gap, as shown in Figure 2. The gap can be left empty or filled with soft material such as Styrofoam which was used in this project. If one desires to add to energy dissipation capacity of the structure at additional cost, the gap can be filled with visco-elastic material.

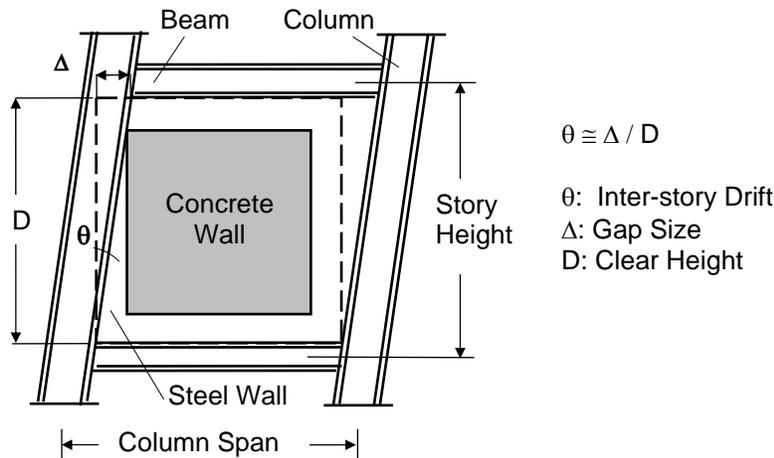
**Figure 3. Function of Gap in the Innovative Composite Shear Wall System**

It is anticipated that the existence of the gap in the innovative composite shear wall system will result in reduction of the system lateral stiffness and change of the reinforced concrete wall behavior under severer seismic events. In the traditional system, both steel and concrete walls are active and provide stiffness and strength from beginning of loading. As a result, not only large forces can be attracted to the structure due to relatively large stiffness of the combined system, but the reinforced concrete wall could be damaged under relatively small lateral displacement. In the innovative system, however, due to the existence of the gap, the concrete wall will not get involved in resisting lateral loads until the inter-story drift has reached certain value, as shown in Figure 3.

When the drift is under the specified value, only steel shear wall and the boundary moment frame provide strength, stiffness and ductility, and the role of reinforced concrete wall is to provide out-of-plane bracing for the steel plate. When the drift is over the specified value, the gap is closed at corners and both steel and concrete walls become active and provide strength, stiffness and ductility. Then the participation of reinforced concrete wall brings in the much needed extra stiffness to help reduce the drift and P-Δ effects, compensates for loss of stiffness of steel shear wall due to yielding, and helps in preventing lateral creep and collapse failure of the structure due to P-Δ effects.

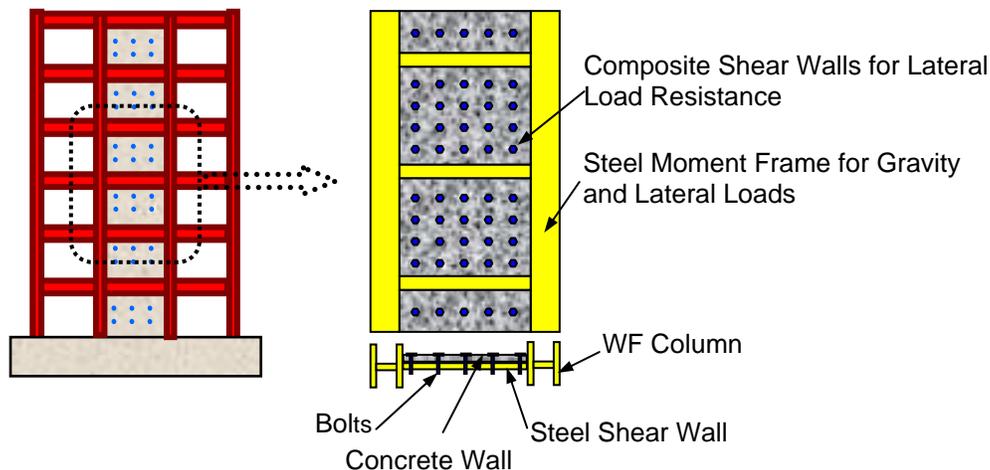
**Figure 4. Generic Structures and Test Specimen**

The test program consisted of cyclic testing of two half-scale specimens. The specimens were constructed as sub-assemblies of a generic building over three floors with composite shear wall system as the lateral load resisting system, as shown in Figure 4. The test specimens represented a dual lateral load-resisting system where composite shear wall is the “Primary” lateral load resisting system welded to a “Back-up” system of special moment-resisting frame.

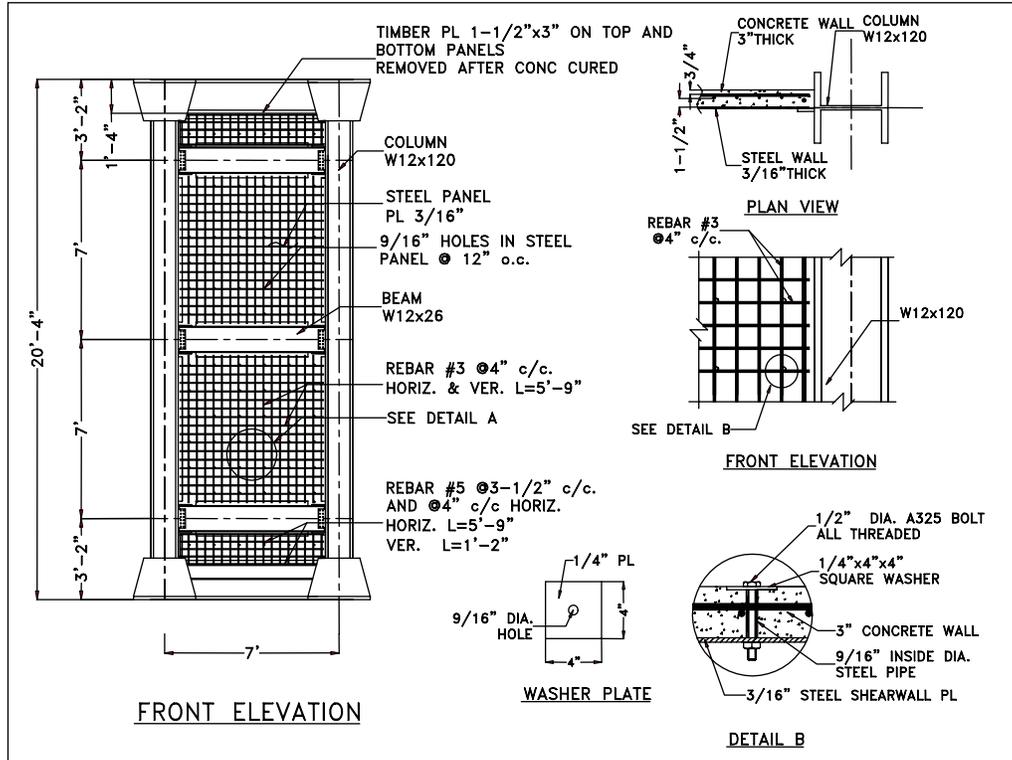
**Figure 5. A Specimen with Details of Concrete Shear Wall**

The two specimens had identical properties except that in Specimen One there was a 32 mm (1.25 inch) gap between the reinforced concrete wall panel and the surrounding steel frame in the two middle stories. Hence Specimen One was representing the “Innovative” Composite Shear Wall System and Specimen Two was representing the “Traditional” Composite Shear Wall System. The major components of test specimens are shown in Table 1 and Figure 5.

In the specimens, the steel wall plate was made of A36 with specified yield stress of 248 MPa (36 ksi). The steel boundary frame was made of A572 Grade 50 steel, with specified yield stress of 345 MPa (50 ksi). The reinforced concrete (R/C) shear wall was made of concrete with a specified  $f'_c$  of 28 MPa (4000 psi) and one layer of reinforcement with a grid of #3 rebar and #5 rebar at perimeter. The R/C walls in the specimen were pre-cast and bolted to the steel walls by 13 mm ( $\frac{1}{2}$  inch) diameter A325 bolts. The pre-cast reinforced concrete walls were cast in the lab.

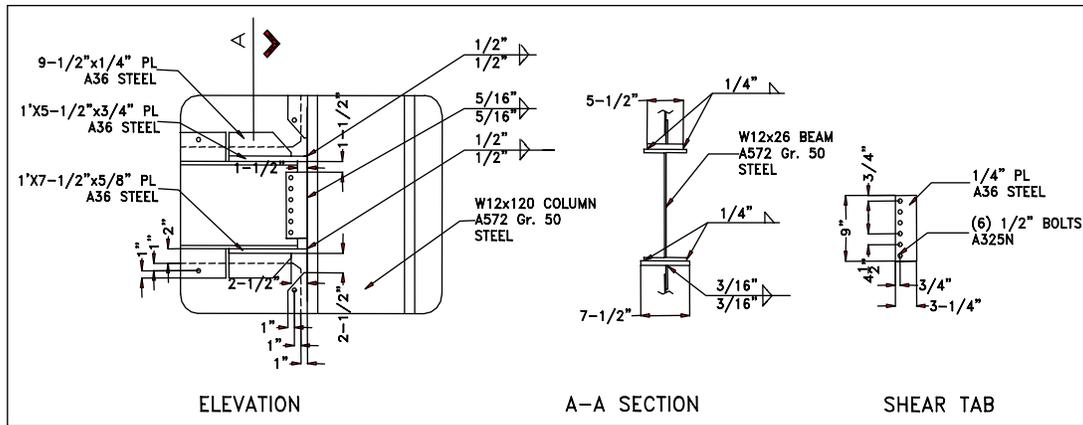
**Figure 6. Beam to Column Moment Connections**

The beam-column connection in the steel frame was cover plate plus shear tab moment connection designed according to FEMA 350 recommendations to make sure that the shear and plastic moment capacity of the beam will be fully developed (FEMA [8]). Some details were modified to accommodate the steel wall plate welded to the moment connection, and further increase the connection rotational ductility. For instance, a vertical fish plate was welded to each cover plate to hold the adjacent steel shear wall in place, and the free length of the cover plates was increased to make the connection even more ductile. Figure 6 shows the details of the moment connections.

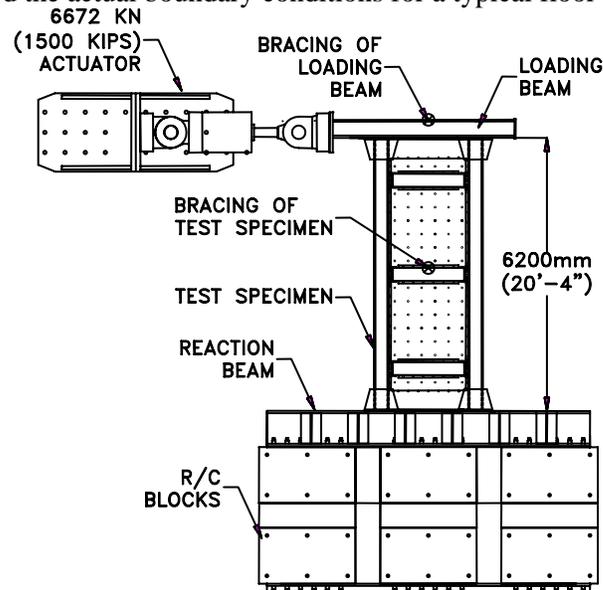
**Figure 7. Test Specimen and Test Set-up**

The test set-up is shown in Figure 7. Main components of the test set-up are: Actuator, Top Loading Beam, Bottom Reaction Beam, R/C Reaction Blocks, and Bracings. The test set-up was designed so that lateral displacements and forces could be applied to the specimen and sufficient factor of safety could be provided under the large forces generated. The test set-up also provided the boundary conditions for the specimen that resembled the actual boundary conditions for a typical floor in a generic structure.

The actuator could provide  $\pm 305$  mm ( $\pm 12$  inch) of maximum displacement and  $\pm 6672$  kN ( $\pm 1,500$  kips) of maximum push-pull force. It was fixed to the laboratory floor using 51 mm (2inch) diameter pre-stressing rods. A cyclic displacement was applied by the actuator to the top of the specimen along with the cyclic load, which resulted in the same story shear for all the stories in the specimen. It represented the shear distribution in the generic structure, since composite shear wall systems are more economical to use in tall buildings where variation of shear forces between adjacent stories are usually very small (Zhao [1]). Gravity loading was ignored since gravity didn't play an important role in the seismic behavior of composite shear walls.

The Loading Beam was connected to the actuator loading-arm at one end and attached to the top end plate of the specimen longitudinally. The Reaction Beam was longitudinally attached to the bottom end plate of the specimen and the R/C Reaction Blocks. The Reaction Blocks were seven reinforced concrete blocks pre-stressed together and to the laboratory floor. The actuator lateral force was then transferred following the path: Actuator – Loading Beam – Specimen – Reaction Beam – R/C Reaction Blocks – Test Floor. In order to simulate bracing effects provided by the floors and prevent out-of-plane movements, bracings were applied at two locations – one to the top flange of Loading Beam, and the other to the top flange of the middle beam of specimen.

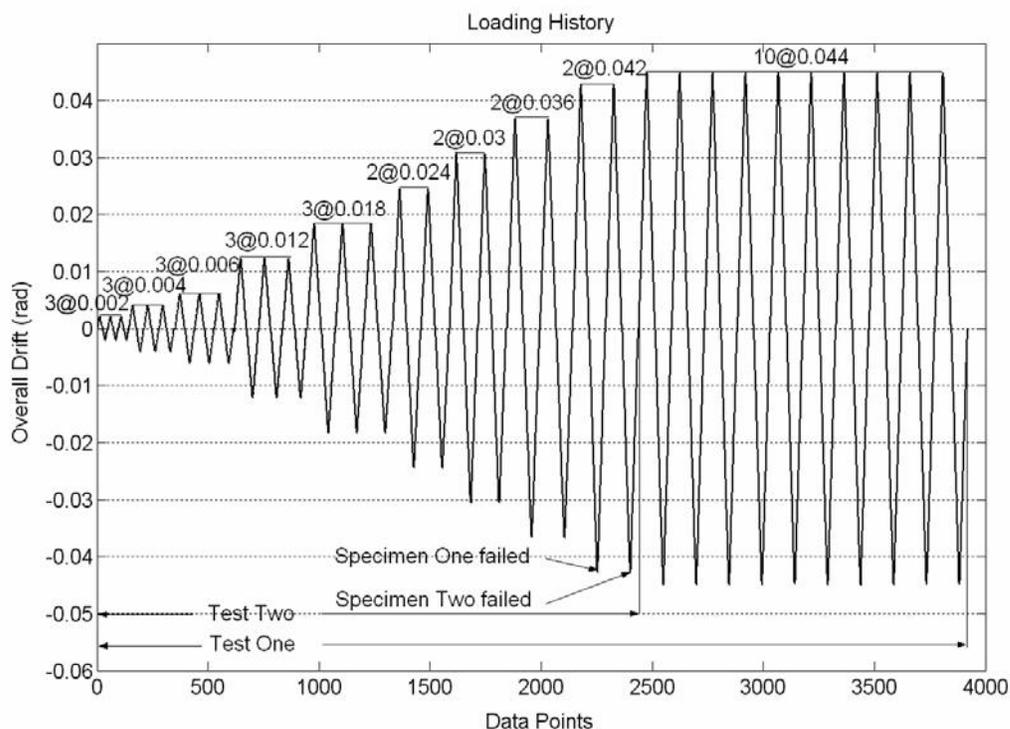
**Figure 8. Loading History Applied to Both Specimens**

Both tests used the same loading history established according to the specifications for Qualifying Cyclic Tests of Beam-to-Column and Link-to-Column Connections in Seismic Provisions for Structural Steel Buildings (AISC [5]). The loading sequence and major events for both specimens are shown in Figure 8. Notice here the loading sequence is given in terms of overall drift, which is defined as the lateral displacement of the actuator divided by the total height of specimen.

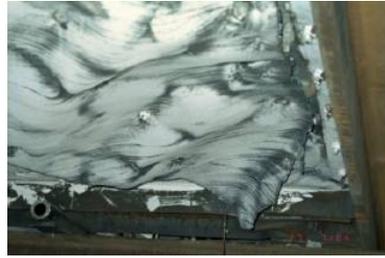
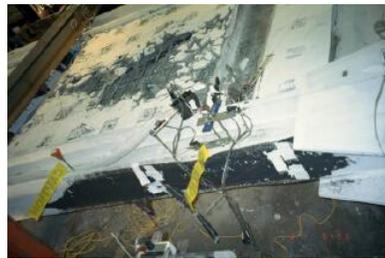
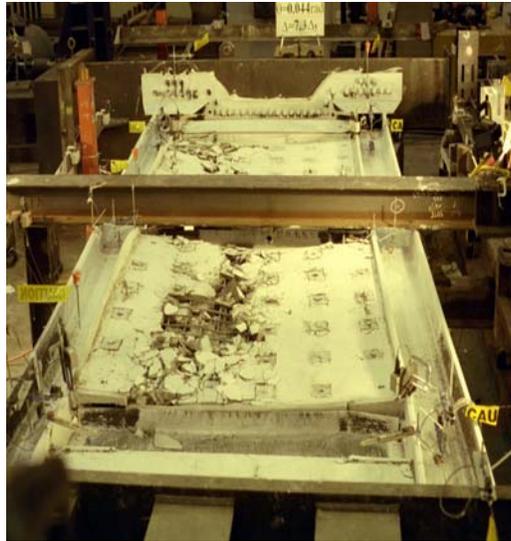
**Figure 9. Specimen One at 7.3  $\delta_y$  (Overall Drift of 0.044)**

Specimen One, with a 32 mm (1.25-in) gap around the R/C panel, behaved in a very ductile and desirable manner. Up to overall drifts of about 0.006, the specimen was almost elastic. At this drift level some yield lines appeared on the beams as well as column base. At overall drifts of about 0.012, the compression diagonal in the steel wall panels was buckling and diagonal tension field was forming. The specimen could tolerate 33 cycles, out of which 27 cycles were inelastic, before reaching an overall drift of 0.044 and maximum shear strength of about 2790 kN (627 kips). At this level of drift, fractures were widespread in the walls and frame members due to low-cycle fatigue, and the connectors between steel wall and concrete wall were almost gone. Shear strength of the specimen dropped to about 80% of the maximum capacity of the specimen, and the specimen was considered failed. Key test observation of Specimen One is summarized in Table 2. Figure 9 shows appearance of different components of Specimen One at the end of the test.

Fracture of Steel wall

Yielding of Column Base

Crushing of Concrete Wall

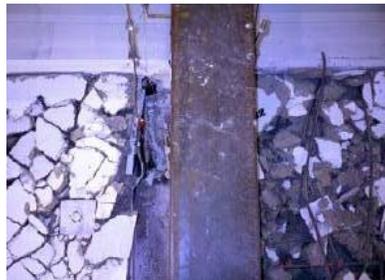
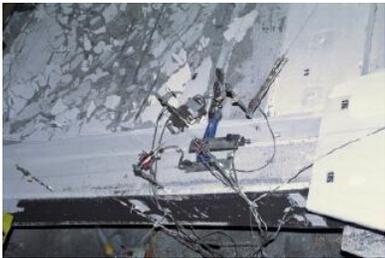
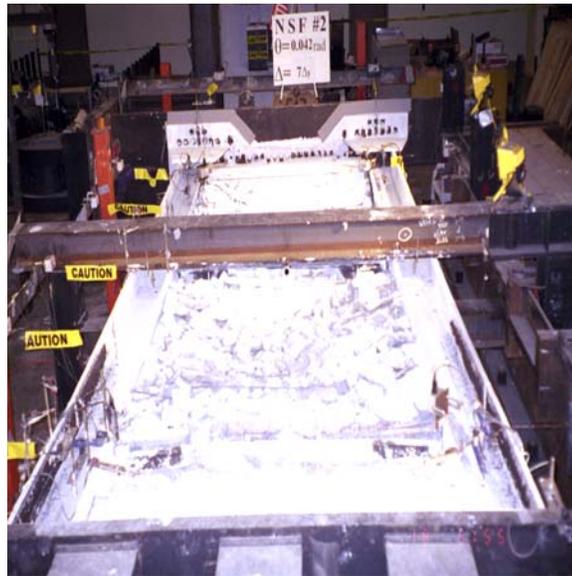
**Figure 10. Specimen Two at  $7\delta_y$  (Overall Drift of 0.042)**

Specimen Two also behaved in a ductile manner. Up to inter-story drifts of about 0.006, the specimen was almost elastic. At this drift level some yield lines appeared on the bottom and middle beam webs as well as column base plate. The specimen was able to reach cyclic overall drift of 0.042 after undergoing 23 cycles, 17 of the cycles being inelastic. The maximum shear force reached was about 3020 kN (679 kips) during the 19th cycle. Throughout the test, the gravity load carrying column remained essentially stable while non-gravity carrying lateral load resisting elements underwent well-distributed and desirable yielding. During 23rd cycle, the upper steel shear wall plate fractured totally along the north and bottom edges due to low-cycle fatigue, and the connectors between steel wall and concrete wall were almost gone. Shear strength of the specimen dropped to about 80% of the maximum capacity of the specimen, and the specimen was considered failed. Key test observation on Specimen Two is summarized in Table 3. Figure 10 shows appearance of different components of Specimen Two at the end of the test.

Fracture of Moment Connection

Yielding of Column Base

Crushing of Concrete Wall

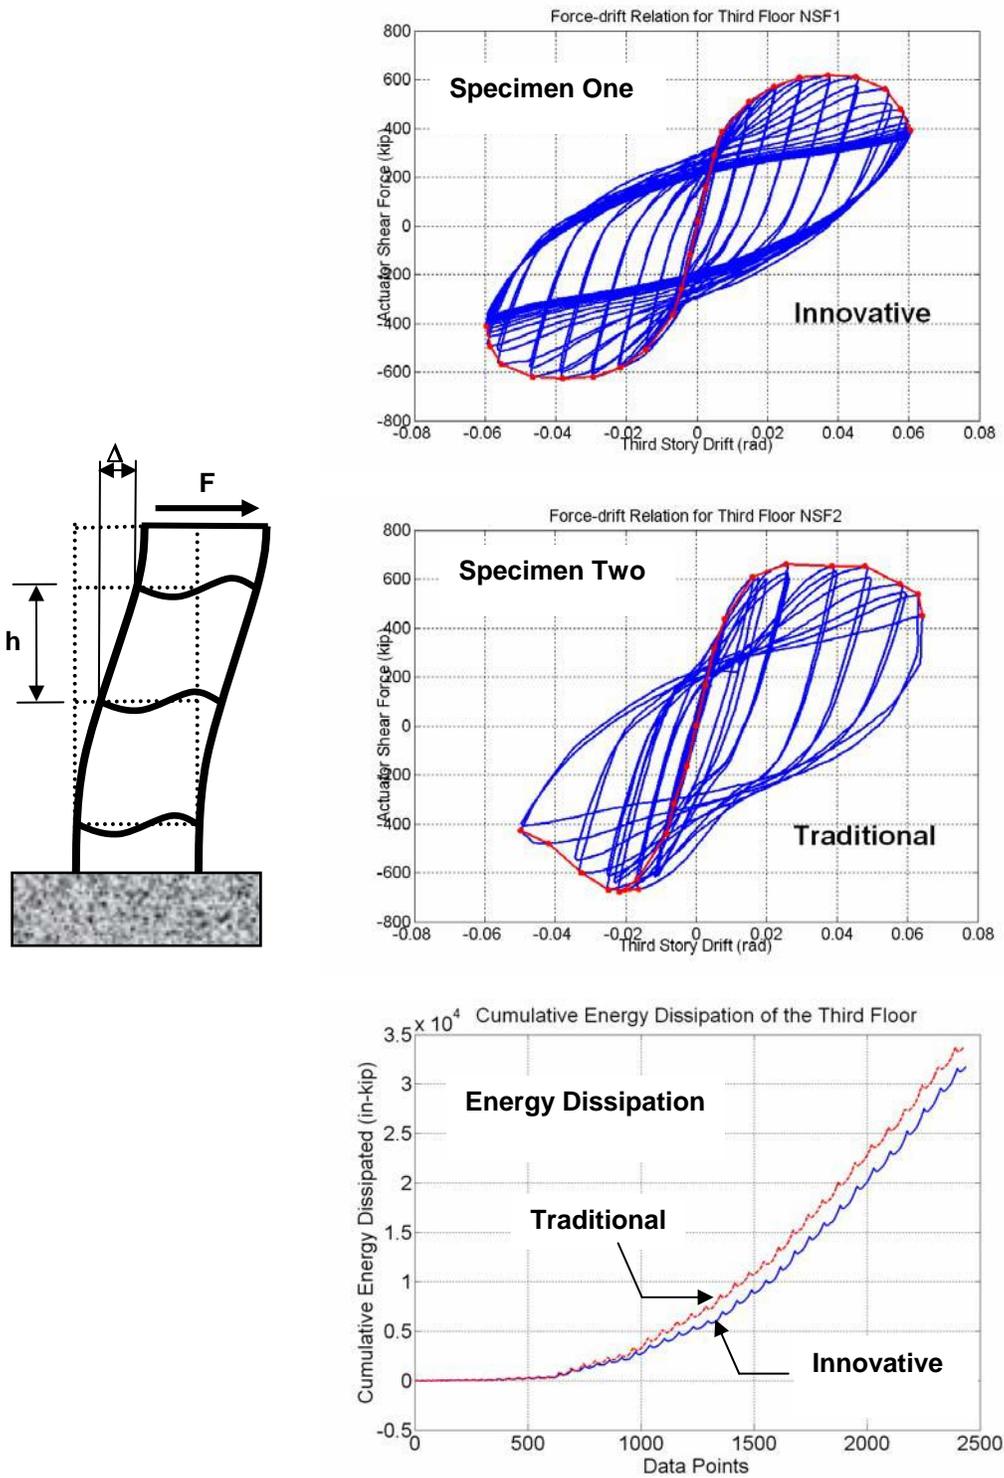
Figure 11. Shear Force- Displacement and Energy Dissipation Curves for Third Floor

Figure 11 shows shear force- drift curves for the third floor of both specimens. The energy dissipation curves for the same story were also shown. From the plots we can see that there is not much difference in the total shear strength or the energy dissipated by the third story for both tests. However, since the damage to the concrete walls in Specimen Two was much severe, the shear force- drift envelope curve for Specimen Two was much less smooth and stable than Specimen One. Therefore there is not much benefit if concrete wall was engaged in resisting the lateral-force from very early stages.

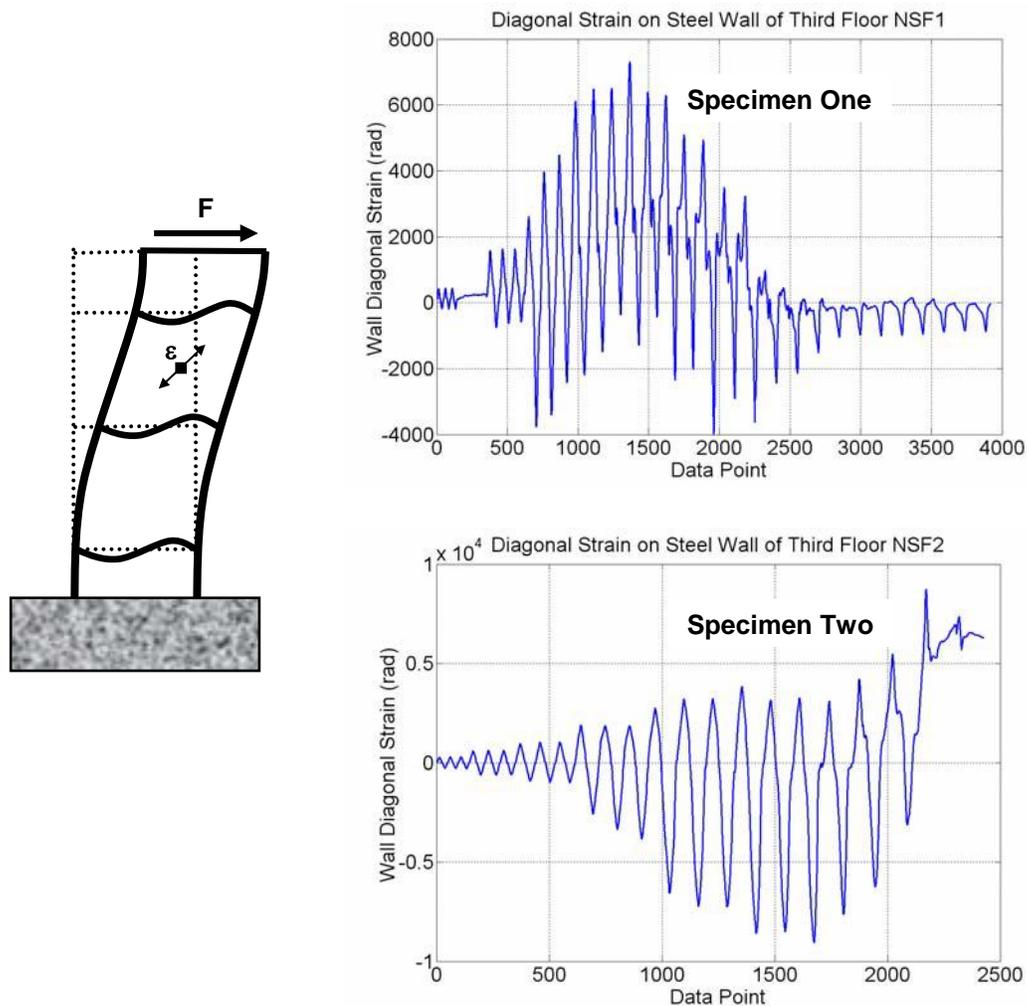
**Figure 12. Diagonal Strain on Third Floor of Two Specimens**

In the two tests, the steel shear walls behaved in a similar manner. The steel walls were intact in the early cycles up to the yield point of 0.006 overall drift. During overall drift of 0.012 to 0.018, the steel plates locally buckled over the free length between the connecting bolts. After that, the wall plates continued to buckle and the connecting bolts started to punch through the wall panel. In both specimens, the steel wall plate started to develop cracks from the corner at about 0.03 overall drift, which finally developed into major cracks and caused the failure of the system at the end. The cracks were most likely caused by the discontinuity of the wall plate at the corner in the shape of a 25mm by 64mm (1 inch by 2.5inch) gap between the steel wall and the moment connections. Decreasing such discontinuity in the connection area would therefore be a major improvement in the design and construction of such shear wall systems. Plots of diagonal strains on the third floor of both specimens were given in Figure 12.
